TWIN CITY LINES

Vol. 3, No.3

THE DOUBLE DECKERS

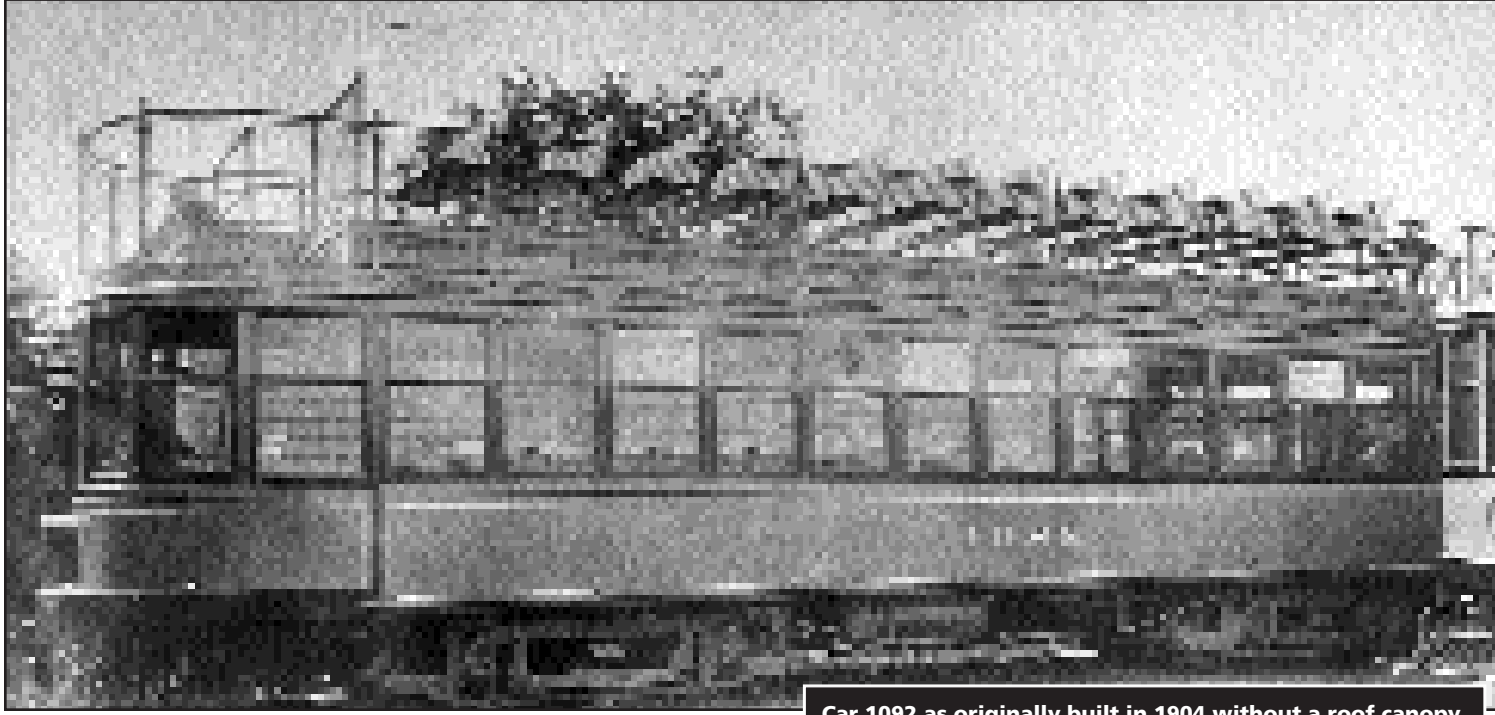
Car 1092 as originally built in 1904 without a roof canopy.

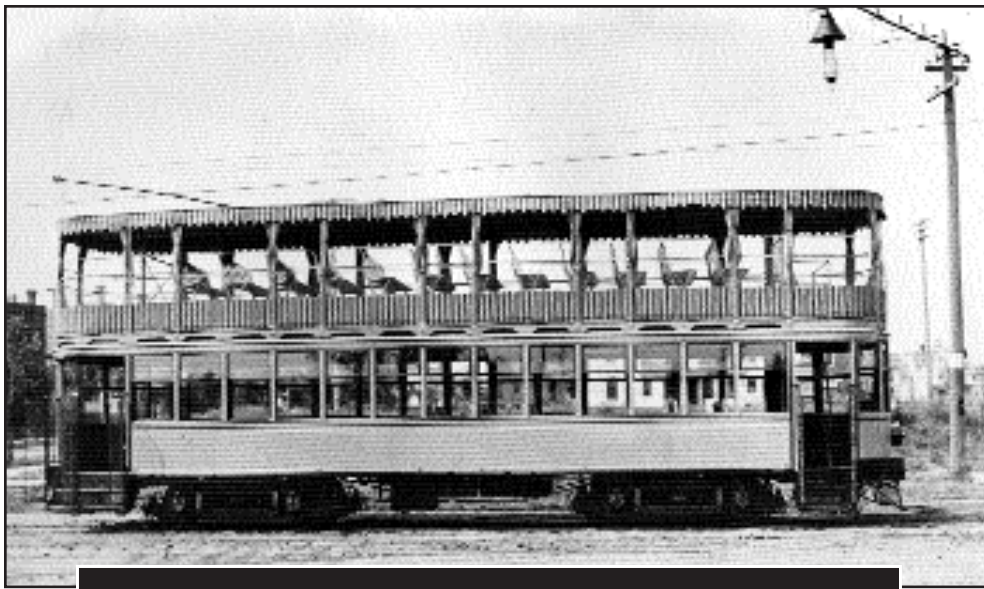
These are official publicity portraits of #1092 after it received its upper deck canopy and side curtains. Although it was probably not used in regular Lake Minnetonka service, the bottom shot was used to illustrate the advertisement at right. It was doctored to show passengers, exterior signs and higher upper deck side canvas.

The Street Railway Journal reported that this car was found unsatisfactory, due largely to insufficient weather protection on the upper deck. To fix this, a full height framework was erected, of one-inch gas pipe bolted to sills, resting on special fittings built permanently into the roof. It supported a canvas canopy roof and side screens, with waterproof folding curtains hung down between the side pipe-posts. Overall height was 16 feet 4 inches compared to 11 feet 5 inches for a standard car. With the upper deck in place the car was reported to weigh 52,000 pounds (compared to 46,700 for a comparable standard car), seating 99 persons and accommodating 65 persons standing.

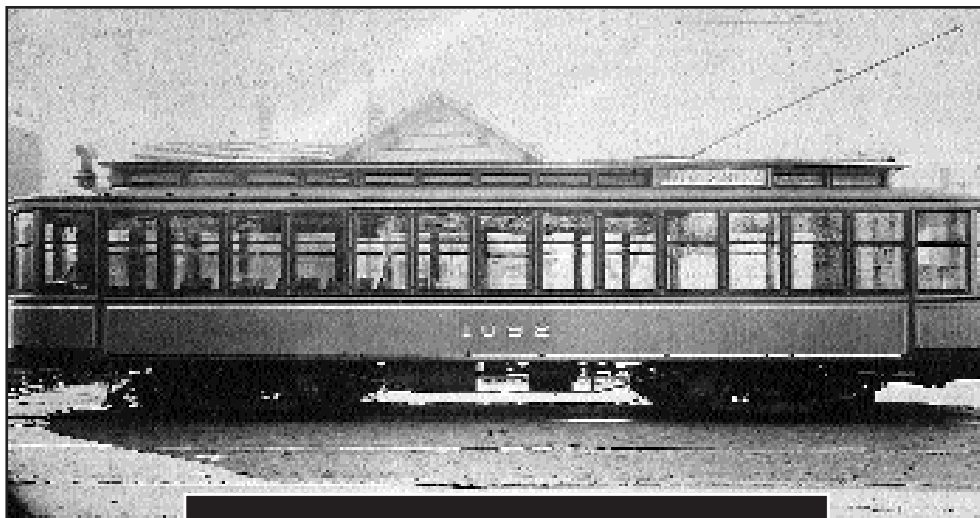
Car 1092 with the upper deck removed. Note the upper deck mounting brackets along the edge of the roof.

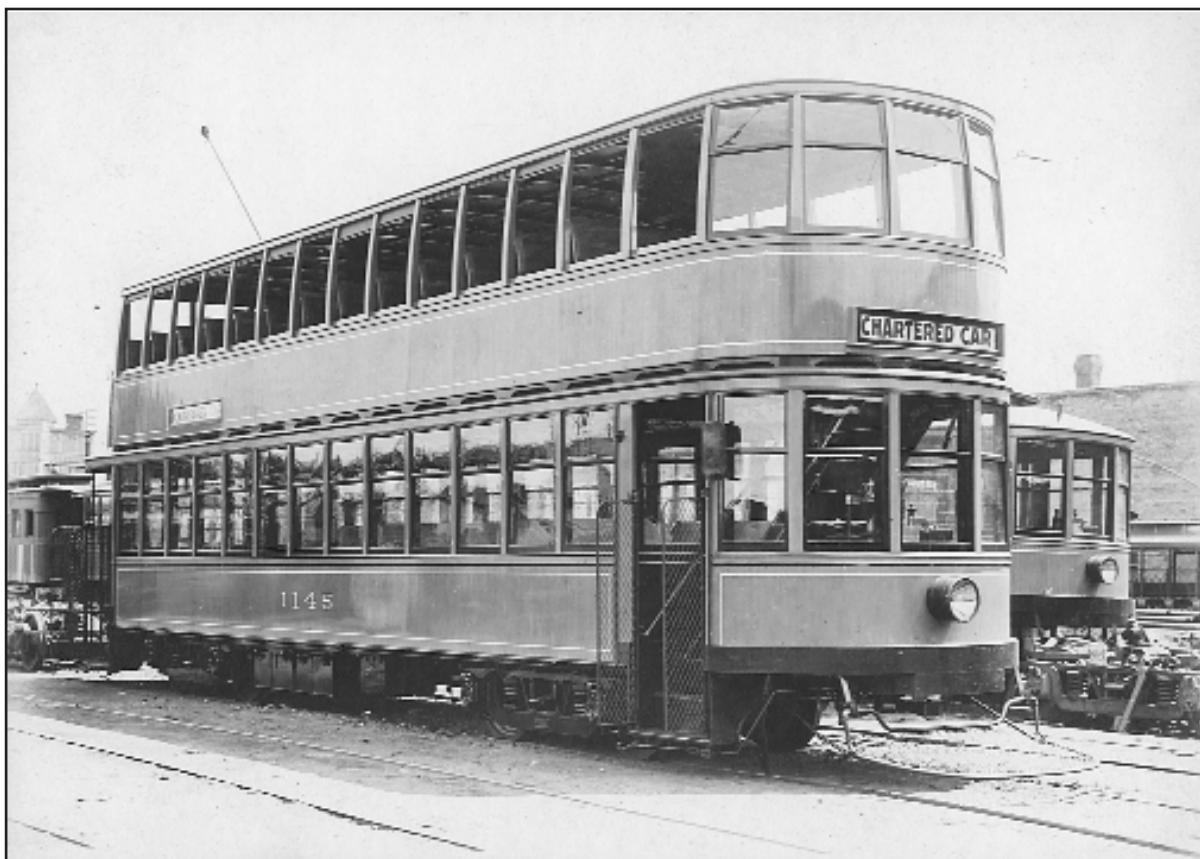
Car 1145 in the 31st Street Station yard, probably in 1906. Note that only the front windows have glass. Pull-down shade offer weather protection in all the other windows. The hand written caption by Everett Jones says "Double deck Lake Minnetonka car used very little."

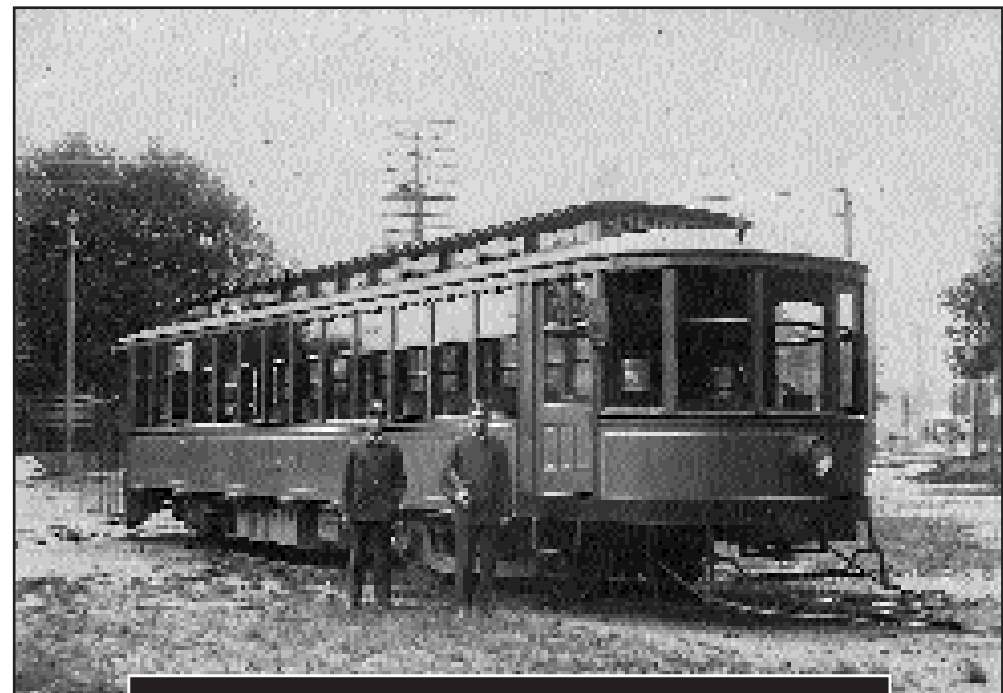
The 50 cars built with reinforced structures to accommodate a second deck ended up in two service groups. Left: Cars 1145-1163 became high-speed suburbans, assigned to the Lake Minnetonka and Stillwater lines. Above: Cars 1164-1195 ran in regular city service and lacked the large motors and other distinctive high-speed features.

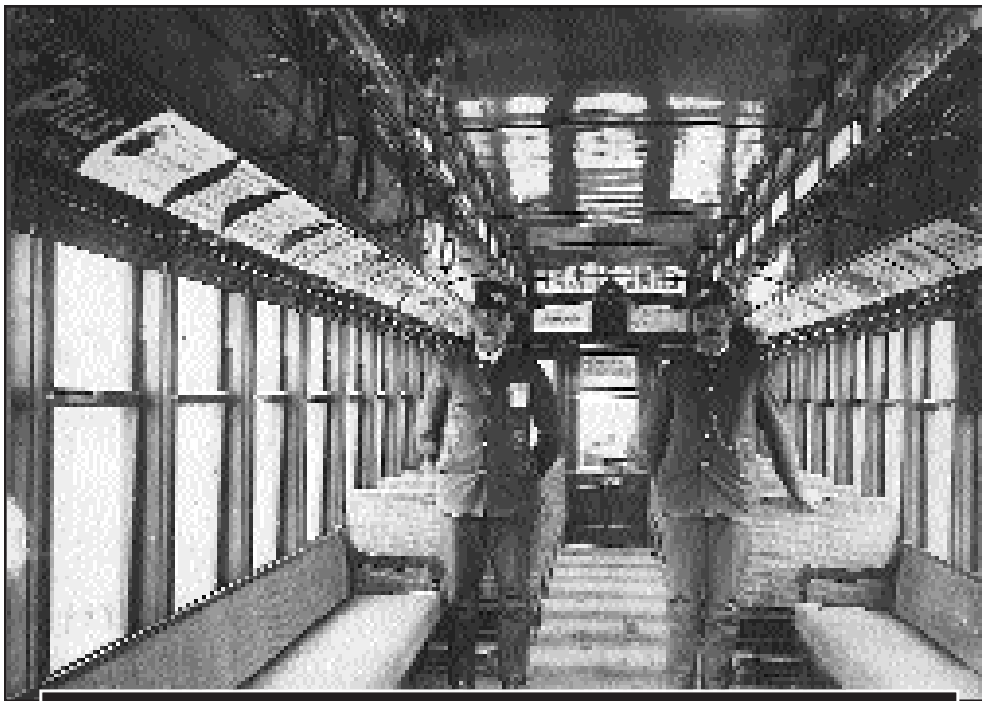
Compare the thickness of the window posts in car 1159 (top), built for double decking, with car 1573, built several years later. By the way, guess which employee is the conductor and which is the motorman. The conductor is at left. Compare the number of pockets in their coats. Conductors needed more on-body storage. Also, conductors were assigned even badge numbers, motormen odd numbers.

To provide for the addition of the upper deck and the load on the roof the body framing was built somewhat heavier than otherwise. The width of the corner posts was increased and the roof carlines were reinforced, so that with the full load on the upper deck the deflection by actual test does not exceed 1/16 inch. At every post the wood carlines are reinforced by steel carlines. In the forward portion of the car, where the presence of the (destination) sign necessitates an extra width of upper window, the steel carlines are 1 inch by 2 7/8 inches."

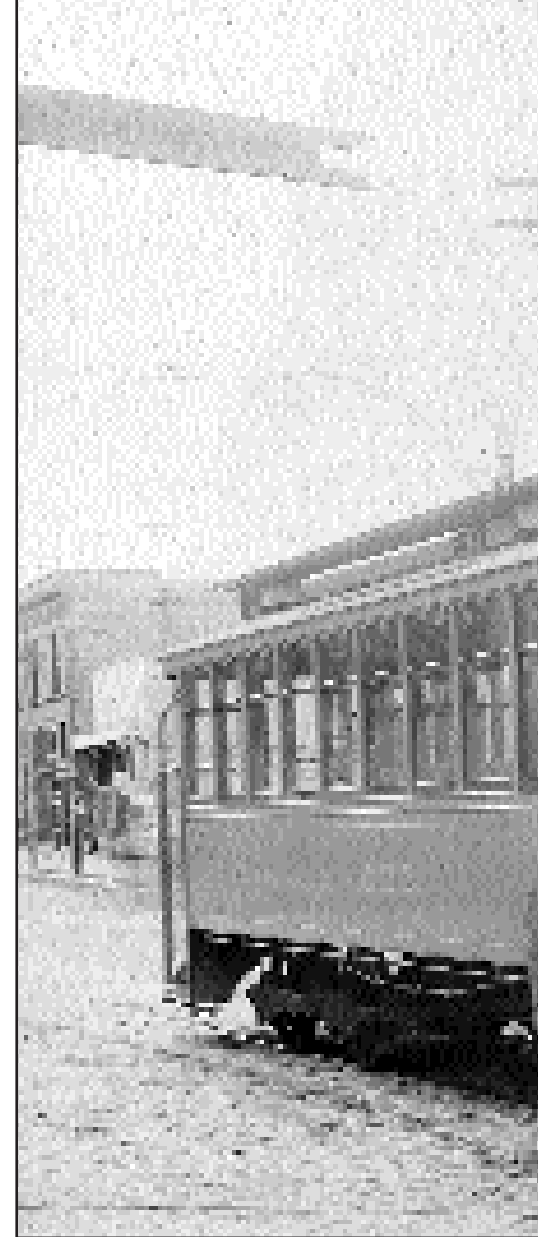
Before 1905, TCRT streetcars had no rear view mirrors, which undoubtedly resulted in rear gate accidents, since the gate was controlled by the motorman. Car 877, riding on its early Bemis trucks, is somewhere on West 7th Street in St. Paul, headed for Fort Snelling. Car 769, equipped with a mirror (and an interesting headlight), appears to be near the end of the Inver Grove line.

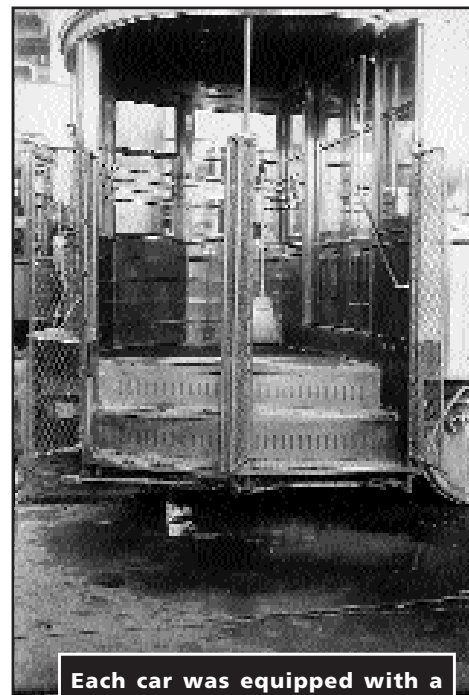
Each car was equipped with a rear vestibule broom and a switch rod. Guess which one was used to turn a switch, much to management's displeasure?

All cars carried a broom in the rear vestibule, as 1300 does today. Do not use the broom handle as a switch rod, in doing so the handles are broken and grease collects on them and when put back in the vestibule passengers come in contact with them and ruin their clothes.

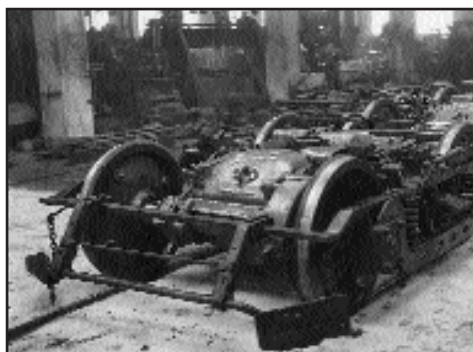
**Snow scrapers mounted
on the front of a truck**

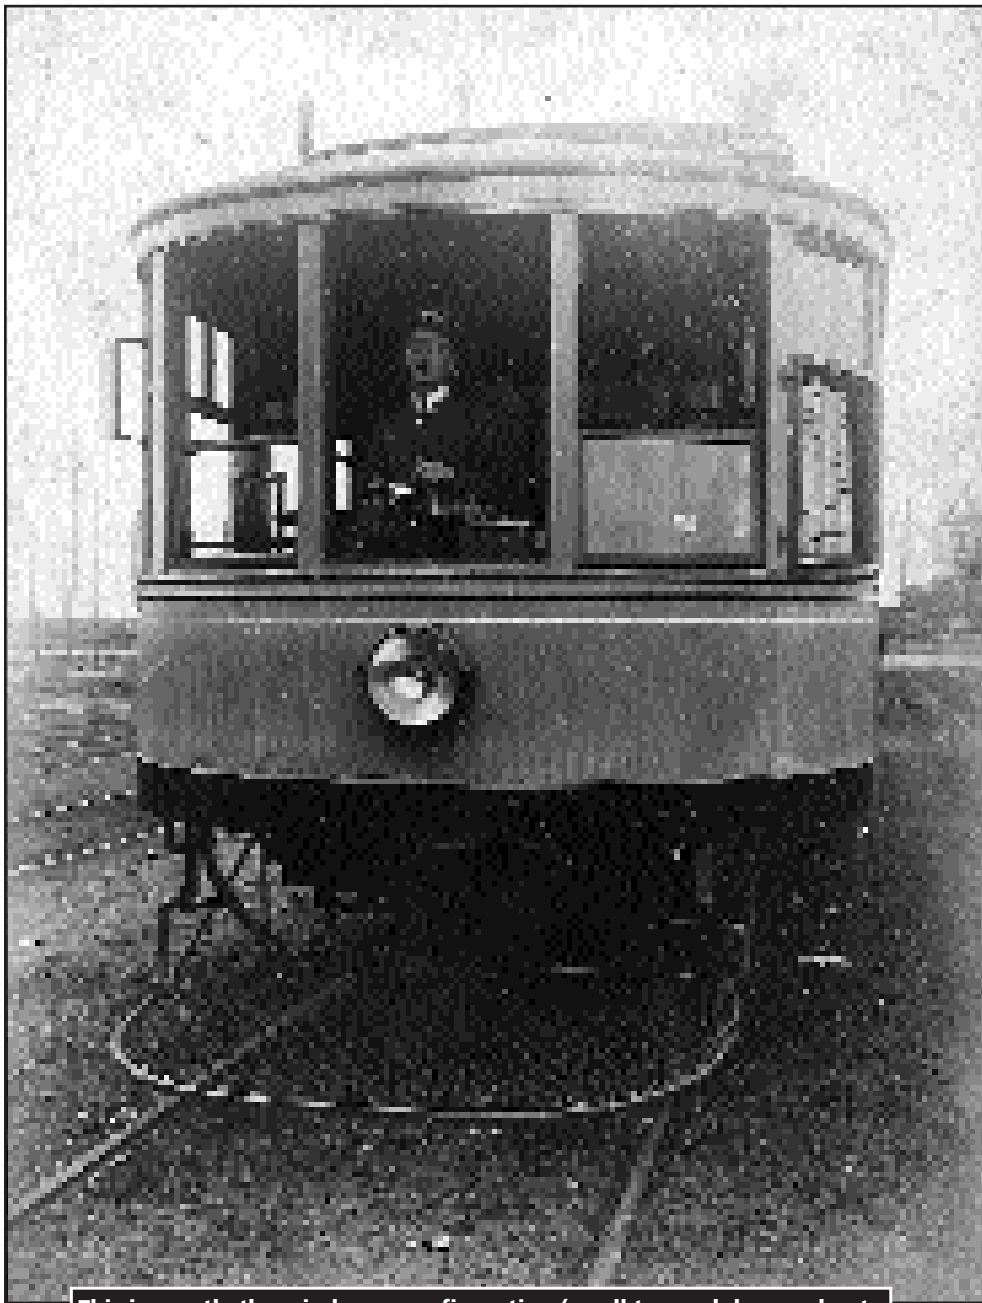
This is exactly the window reconfiguration (small top sash lowered onto the sill) that the bulletin prohibited. Better ventilation was the goal.

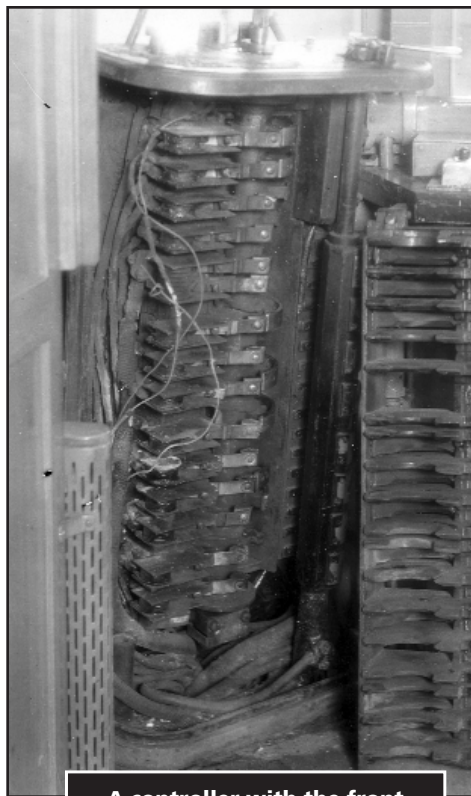
A controller with the front cover off revealing the rotating drum with "finger" contacts.

Controller contacts were normally lubricated with Vaseline, which could withstand much of the arcing at the contacts. It also tended to maintain a lubricating coating on the surfaces of the finger contacts and drum segments. Oil would not maintain that lubricating film,

and dry contacts are more prone to arcing, as well as increased wear. There is also the hazard of shards from the cotton waste being shed upon the contacts, leaving oily remnants that could catch fire quite easily. In addition, those shards could prevent proper contact between the fingers and the segments, possibly exacerbating the arcing problem.

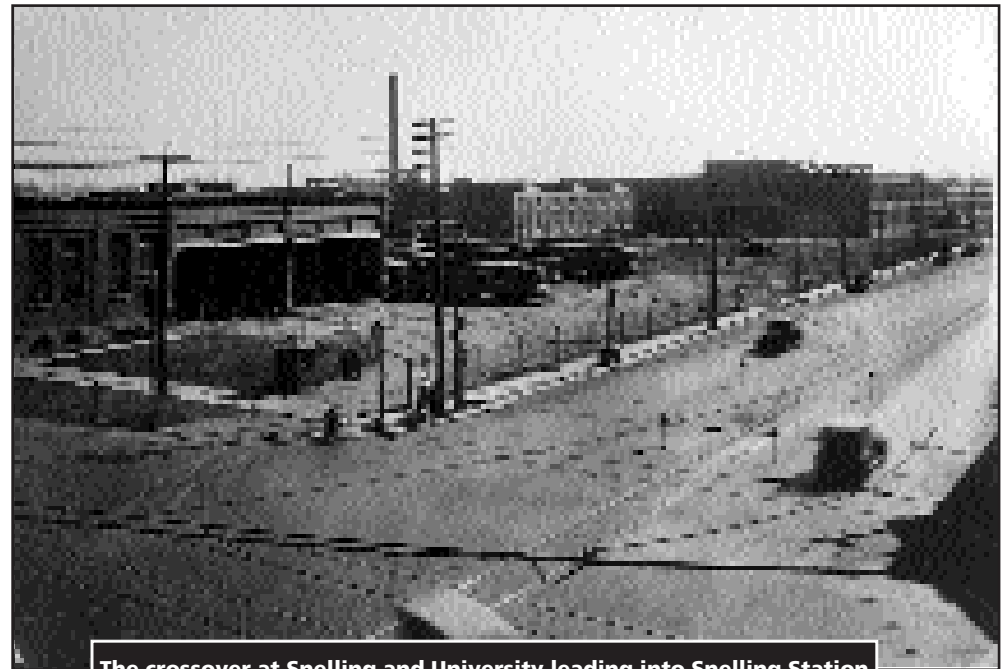
The crossover at Snelling and University leading into Snelling Station

It is of the greatest importance that the cross-over on University Avenue at Snelling Station and also the one just west of Snelling be closed, that is, set for the main line at all times. Both conductor and motorman of any pull-in cars using these cross-overs will be held strictly accountable for the closing of these switches. Should there be more than one car at the same time to pull through the cross-over it shall be the duty of each conductor to see that the cross-over is closed after his car passes.

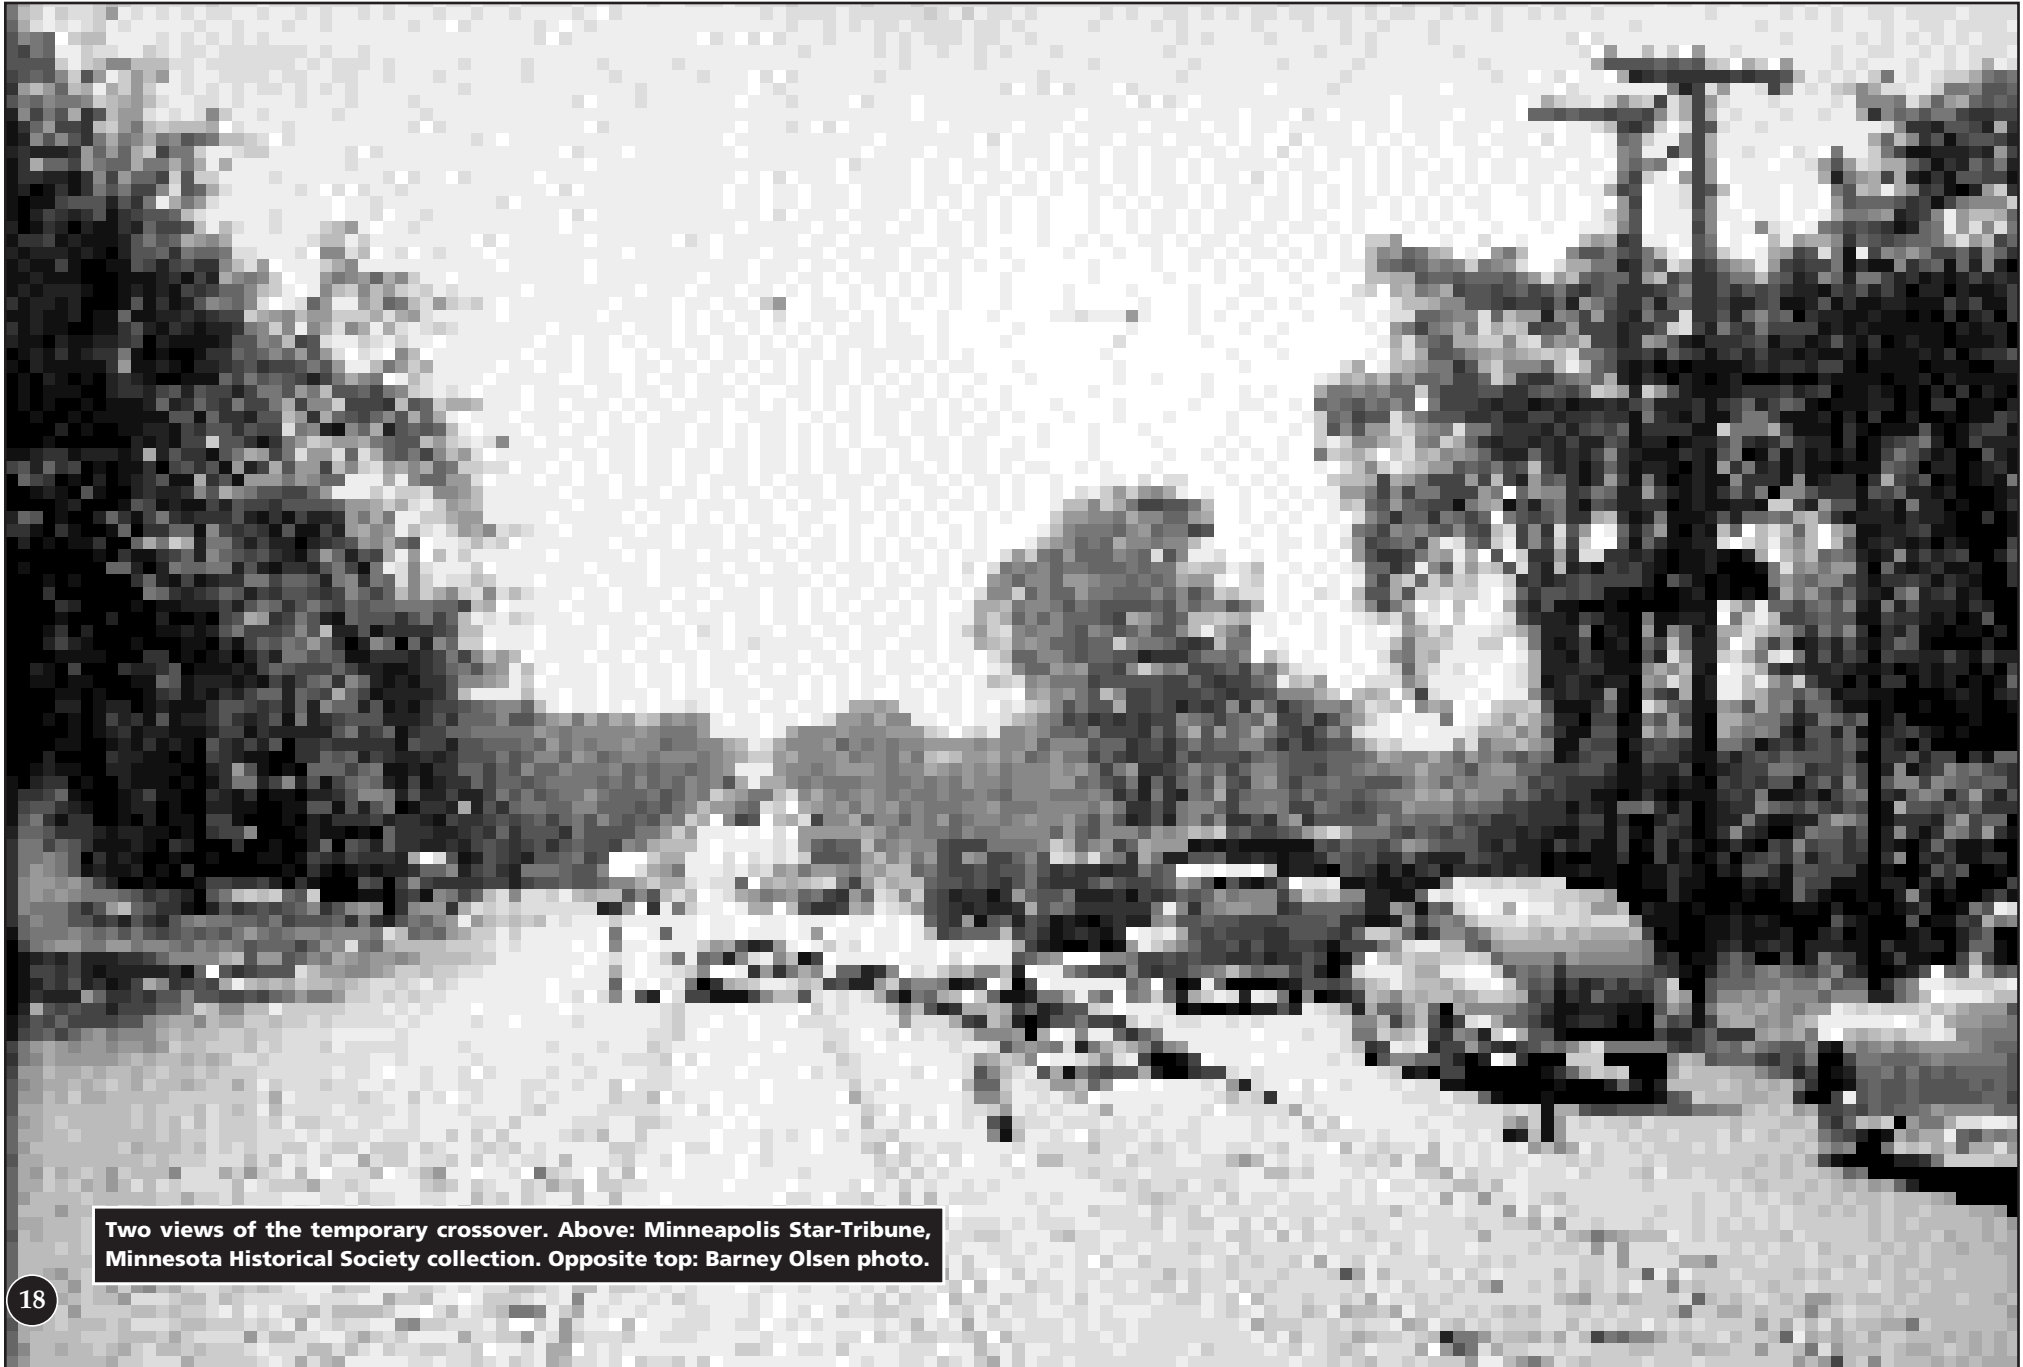
Two views of the temporary crossover. Above: Minneapolis Star-Tribune, Minnesota Historical Society collection. Opposite top: Barney Olsen photo.

In 1950 the 45-year old Lake Street bridge over the Mississippi River received a new deck. Streetcar service was maintained by removing one track from service, replacing that portion of the deck, and then shifting to the other side. A temporary crossover was installed at the St. Paul end of the bridge.

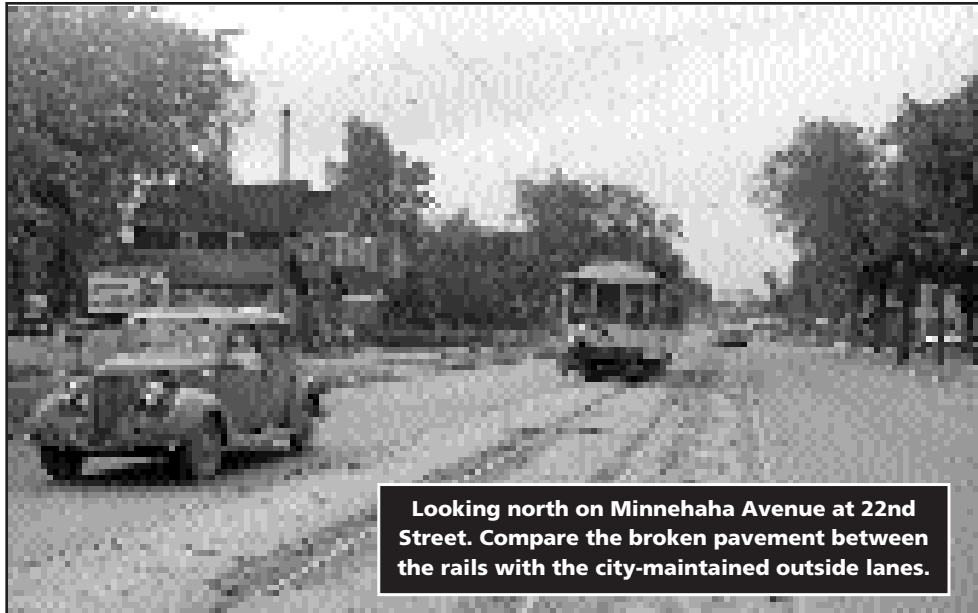
Looking north on Minnehaha Avenue at 22nd Street. Compare the broken pavement between the rails with the city-maintained outside lanes.

The TCRT's city franchises required it to pave and maintain the pavement in the track portion of the street. By 1950, TCRT lacked the money to comply and let the maintenance lapse. Many streets were only oil and compacted dirt, and tended to break up badly during spring thaw. The Minneapolis Star-Tribune documented some of the worst places. On France Avenue, the desire of the City of Edina to fix their side of the street caused them to block the streetcars in 1952 and force abandonment of the line between 44th and 54th Streets. All Minneapolis Star-Tribune photos, Minnesota Historical Society collection.

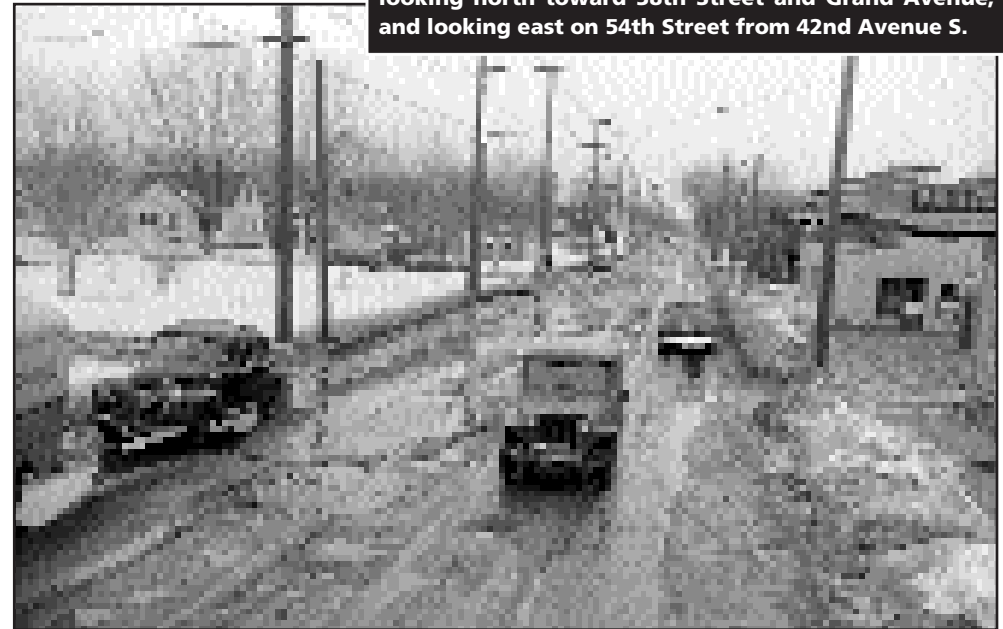
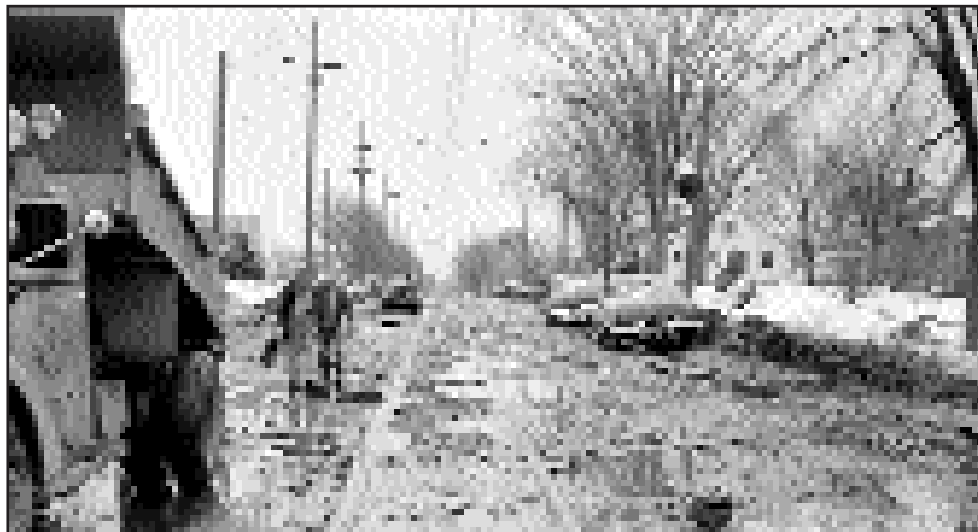
Bad pavement on France Avenue S. at 45th Street (right) and 54th Street. That's the wye switch in the foreground. Note the round block signal for the single track on the pole above the nearest parked car.
